Home Inspection Report

1111 Customized Sample Report
Colorado Springs, Colorado

Estimated Age 44 Years Entrance Faces West
Inspection Date 03/21/2009
Temperature 65 Degrees
Lighting/Weather Partly cloudy Soil Conditions Dry
Amount Received: \$275

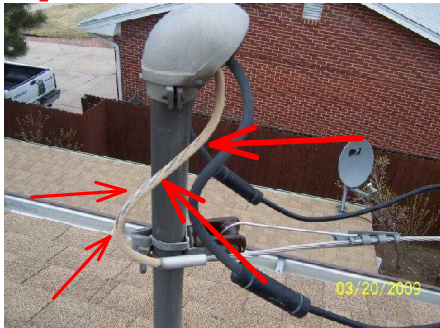
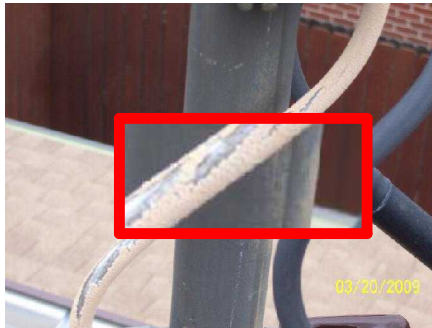
Poor

Electrical Mast: Mast with tie back at roof **The insulation on the Neutral wire at the mast is worn away and leaves an exposed area. Recommend immediate repairs.**

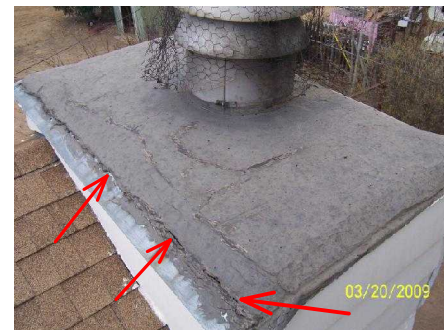
Marginal

Chimney Flashing: Tar covered **Note that Chimney cap has been covered with Tar. This is an unconventional repair although it may be sufficient. We recommend sealing the cracks in the tar seal where it has shrunk. The chimney cap was not directly visible as it was under the tar.**

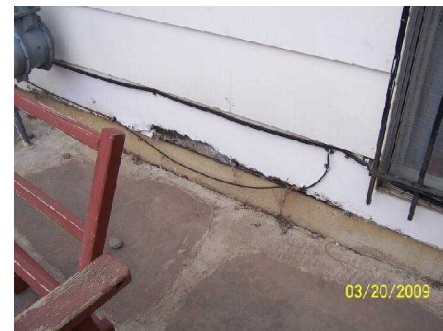
Marginal

Siding Type: Fiberboard **Fiberboard siding damaged/deteriorated**

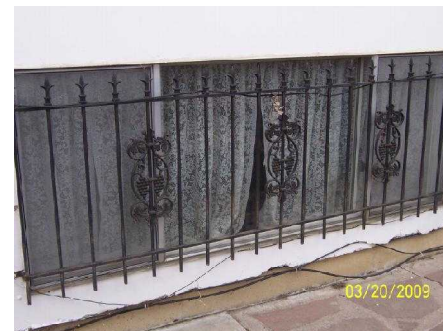
Poor

Windows: Vinyl, Wood, Metal **Bars on basement windows interfere with proper fire escape. Recommend remove one or more, or change style to one that has a latch that can be opened manually if needed.**

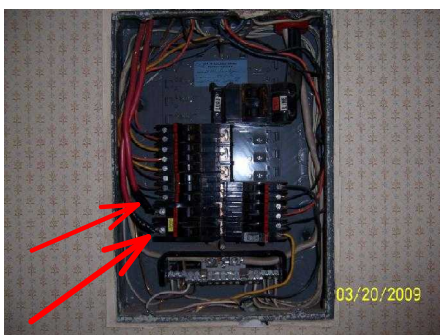
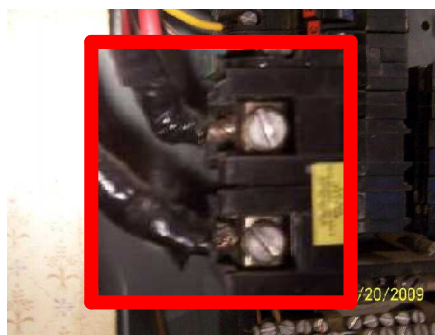
Room just in from garage. Electric Panel

Poor Manufacturer: Federal Pacific Federal Pacific panel breakers have a history of not tripping when circuit overloading exists. Recommend evaluation by licensed electrical contractor for evaluation and replaces as recommended.

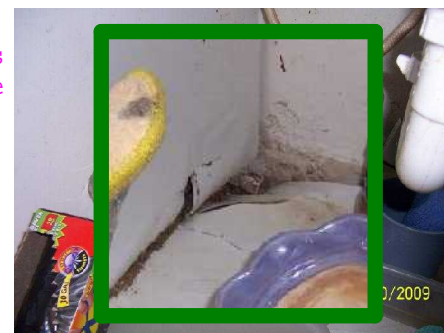
1st Floor Kitchen

Not Inspected	Range/Oven
Poor	Disposal: In-Sinkerator Jammed
Satisfactory	Refrigerator: Kenmore
Satisfactory	Electrical: 120 VAC/240 VAC
Satisfactory	Plumbing/Fixtures: Chrome
Marginal	Cabinets/Countertops Formica Water damage present under the counter. I am concerned that what looks like wood water damage under the sink area may be as a result of pests (termites). I recommend having a termite inspection done to come to a firm conclusion.

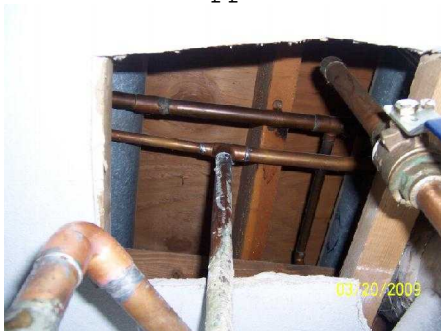
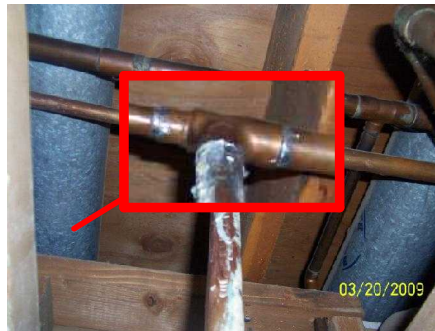
Marginal

Water Lines: Copper Active leak above water heater.
